## ACCIDENT

<b>Aircraft Type and Registration:</b>	Magni gyroplane M24C Orion, G-CGTI	
<b>No &amp; Type of Engines:</b>	1 Rotax 914-UL turbocharged piston engine	
<b>Year of Manufacture:</b>	2010	
<b>Date &amp; Time (UTC):</b>	28 April 2011 at 1131 hrs	
<b>Location:</b>	North of Hilltop Way, near Old Sarum Airfield, Wiltshire	
<b>Type of Flight:</b>	Private	
<b>Persons on Board:</b>	Crew - 1	Passengers - None
<b>Injuries:</b>	Crew - 1 (Fatal)	Passengers - N/A
<b>Nature of Damage:</b>	Aircraft destroyed	
<b>Commander's Licence:</b>	Private Pilot's Licence (Gyroplanes)	
<b>Commander's Age:</b>	51 years	
<b>Commander's Flying Experience:</b>	128 hours (of which 25 were on type) Last 90 days - 20 hours Last 28 days - 7 hours	
<b>Information Source:</b>	AAIB Field Investigation

## Synopsis

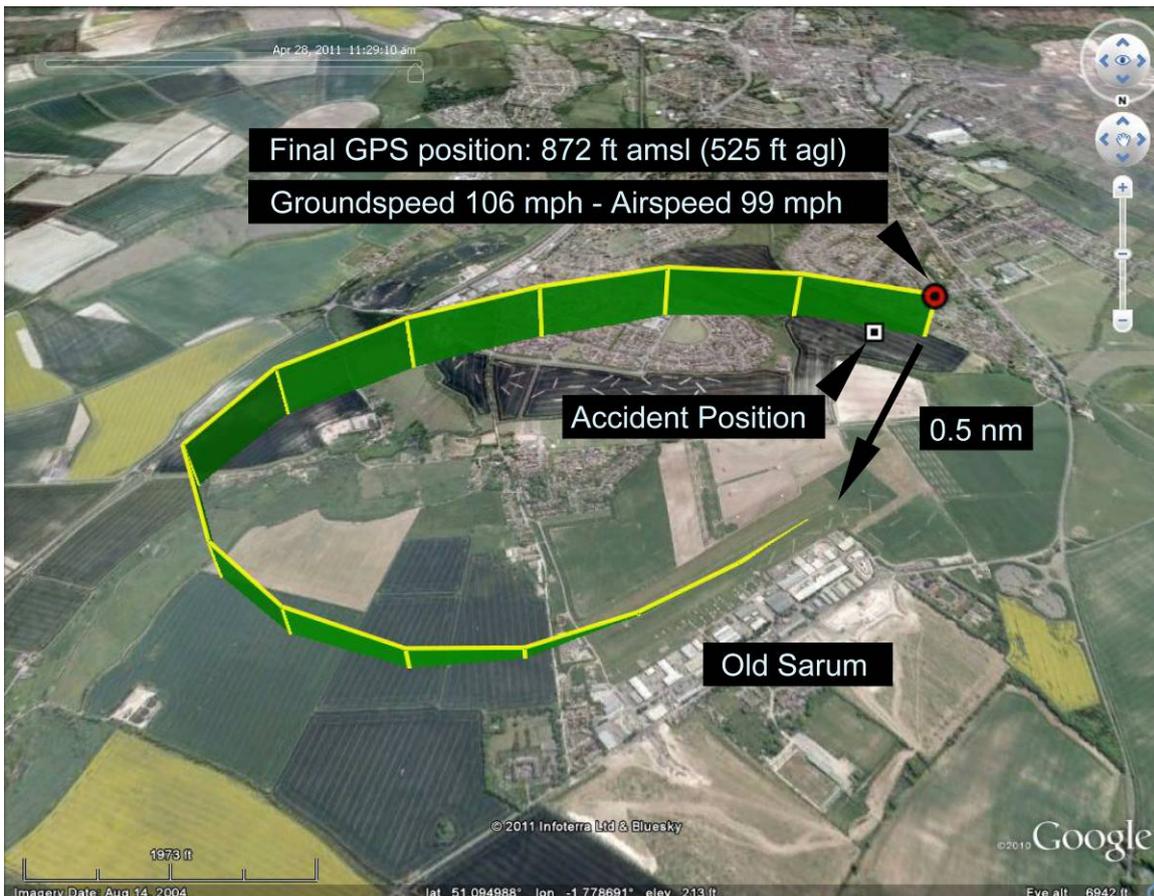
**Figure 1**  
GPS Track from Old Sarum (view looking south)

At 121 seconds after the initial data point, the aircraft was at an altitude of 872 ft amsl (587 ft above nominal airfield level - the published circuit height at Old Sarum was 600 ft for this aircraft type). Ten seconds later, at 1129:34 hrs, the final data point was recorded.

The altitude was the same as the previous data point, being 872 ft, although the airspeed had increased from approximately 84 mph to about 99 mph, which is faster than the typical airspeed of 60 to 70 mph. The aircraft was on a track of 291° and due to rising ground the approximate height reduced to 525 ft. The final position placed the aircraft 160 m to the west of the accident position and approximately 0.5 nm from the threshold of Runway 06.

The track log file was closed at 1130:04 hrs, indicative that the GPS signal had been lost for the past 30 seconds. The reason for the loss of the GPS signal could not be fully established. However, as no external GPS antenna was fitted, it is most likely that the aircraft entered a series of

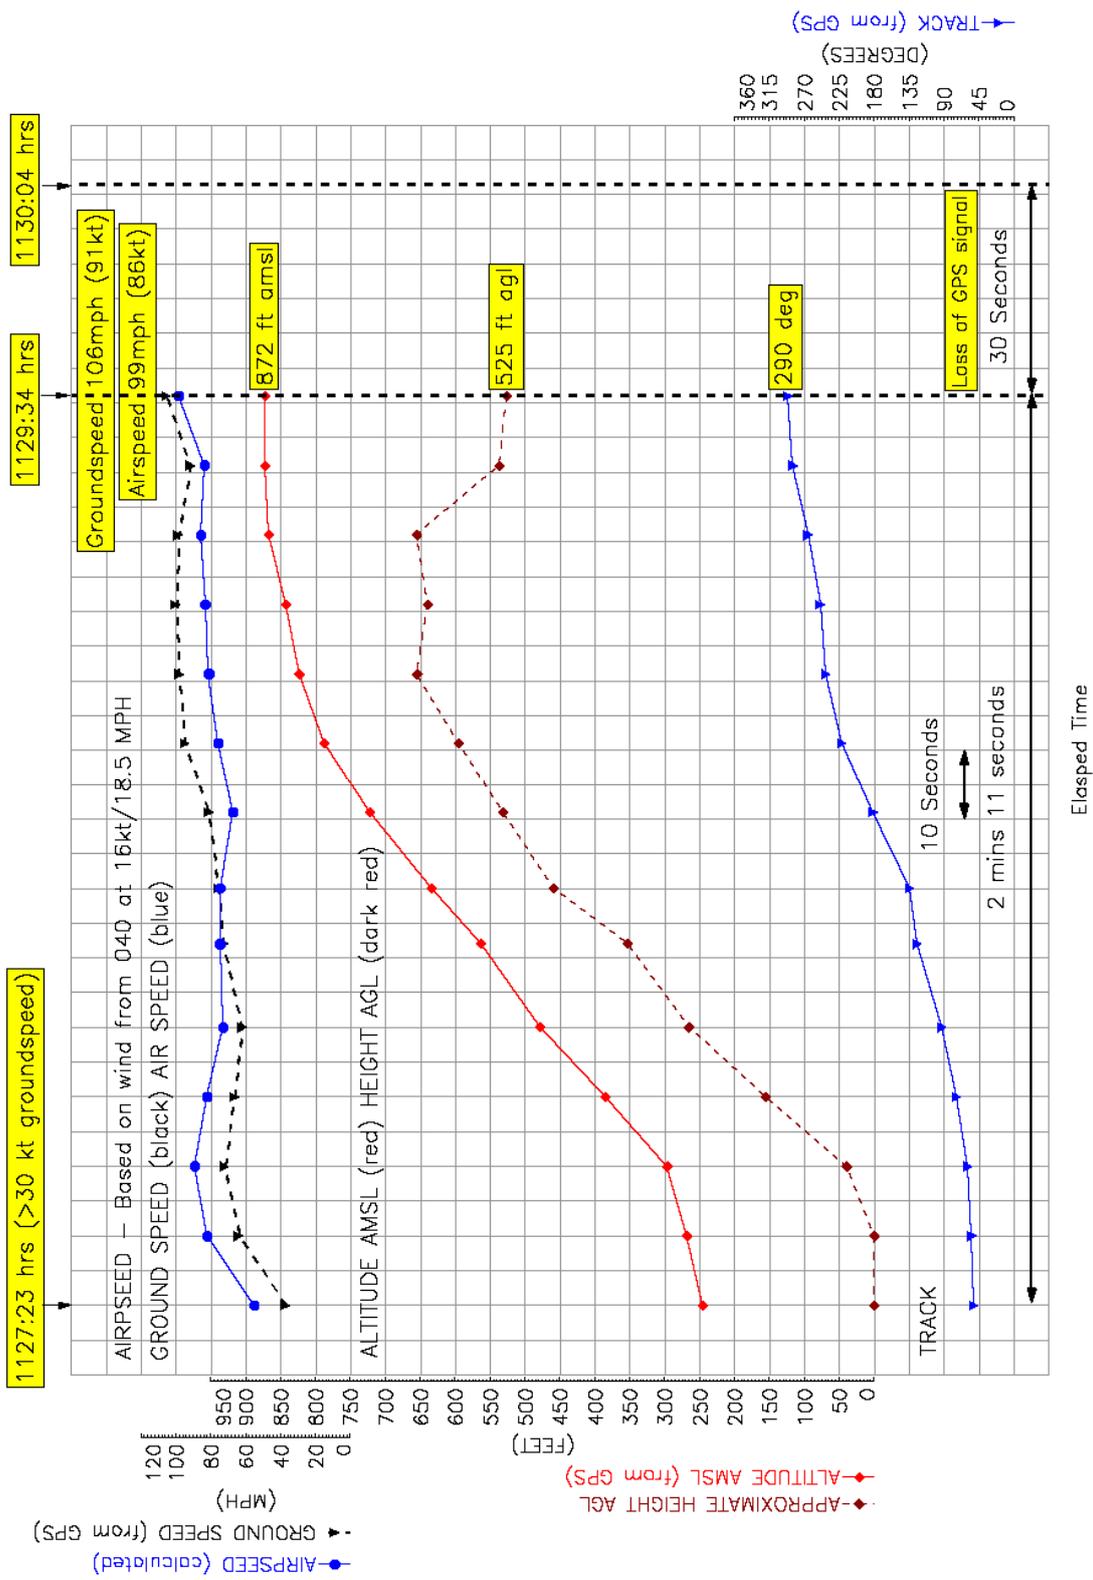
**Figure 2**  
GPS Track points with derived airspeed

A total of 14 data points were recorded over a period of two minutes eleven seconds. From the GPS groundspeed, an approximate airspeed has been derived based on a calculation of the wind at 600 ft being from 040° at 18 mph.

At 1127:23 hrs, with the aircraft positioned near to the threshold of Runway 06, the first data point was logged at a ground speed of 37 mph and at a recorded altitude within 11 ft of the actual terrain altitude. The aircraft then proceeded to track the runway before climbing and making a right turn (Figures 1 and 2). The aircraft climbed steadily at an average rate of approximately 500 ft/min and an average airspeed of about 79 mph, whilst positioning onto an approximate downwind track.

Analysis of the data by the aircraft manufacturer indicated that the airspeeds and climb rate were consistent with maximum, or near to maximum, engine power having been selected throughout the period of the recorded data.

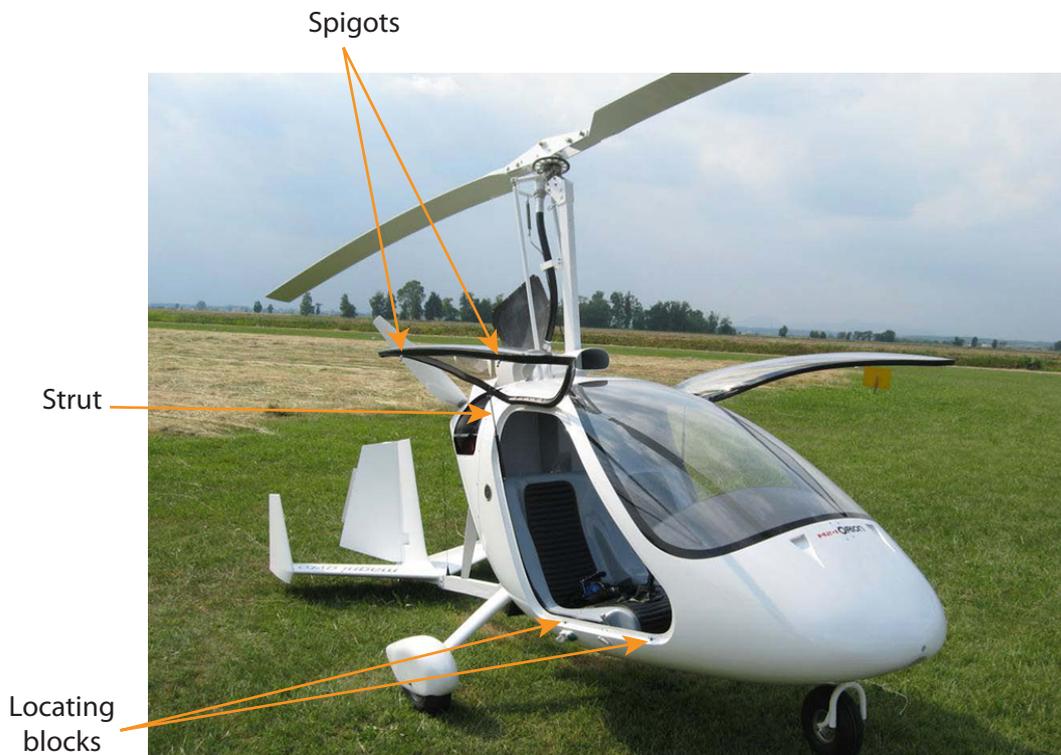
**Figure 3**  
Door arrangement

A ‘gull-wing’ (upward opening) door is fitted to each side of the cockpit and is attached to the aircraft by a hinge fitted to the top edge of the door frame, see Figure 3. A strut is fitted to the rear of the door and holds the door open when the aircraft is on the ground; the strut also limits the upward movement of the door. The door is secured in the closed position in flight by two spigots mounted on the lower section of the door frame, which

engage in locating blocks mounted on the inside of the door sills.

The spigots are locked in place by shoot bolts operated by the door lock levers. The bolts are in the unlatched position (open) when the internal lock lever is just aft of the vertical and in the latched position (closed) when the internal lock lever is in the forward, over-centred position, flush with the door sill, see Figure 4. A 'knob' on the lower part of the door frame allows the door to be held closed while the locking mechanism is engaged. While the doors may be open during taxi, the aircraft is not approved to fly with them in the open position.

The investigation determined that it requires two hands to close and lock the door. Moreover, it is not possible to check visually, while seated in the aircraft, that the rear spigot is latched in the locating block by the shoot bolt. The only way to check that the spigots are correctly engaged and latched is to push on the door.

- A Service Information Leaflet (SIL-001-2011 dated 19 May 2011) was sent by Magni Gyro UK to all owners and operators of the M24C on 23 May 2011 highlighting the importance of performing checks on the security of the door latching prior to commencing the takeoff. It also stated that a door opening in flight is unlikely to become detached or adversely affect the aircraft's handling and recommended that in such an event the airspeed should be limited to around 50-60 mph and the aircraft landed in an unhurried and controlled fashion as soon as possible.

the status of the latching mechanism. These include: microswitches to confirm the position of the aft door locking pin and shoot bolt, a red warning light to warn if a door is not correctly latched and a change to the digital rotor rpm gauge so that the display will be blanked if a door is not latched correctly.

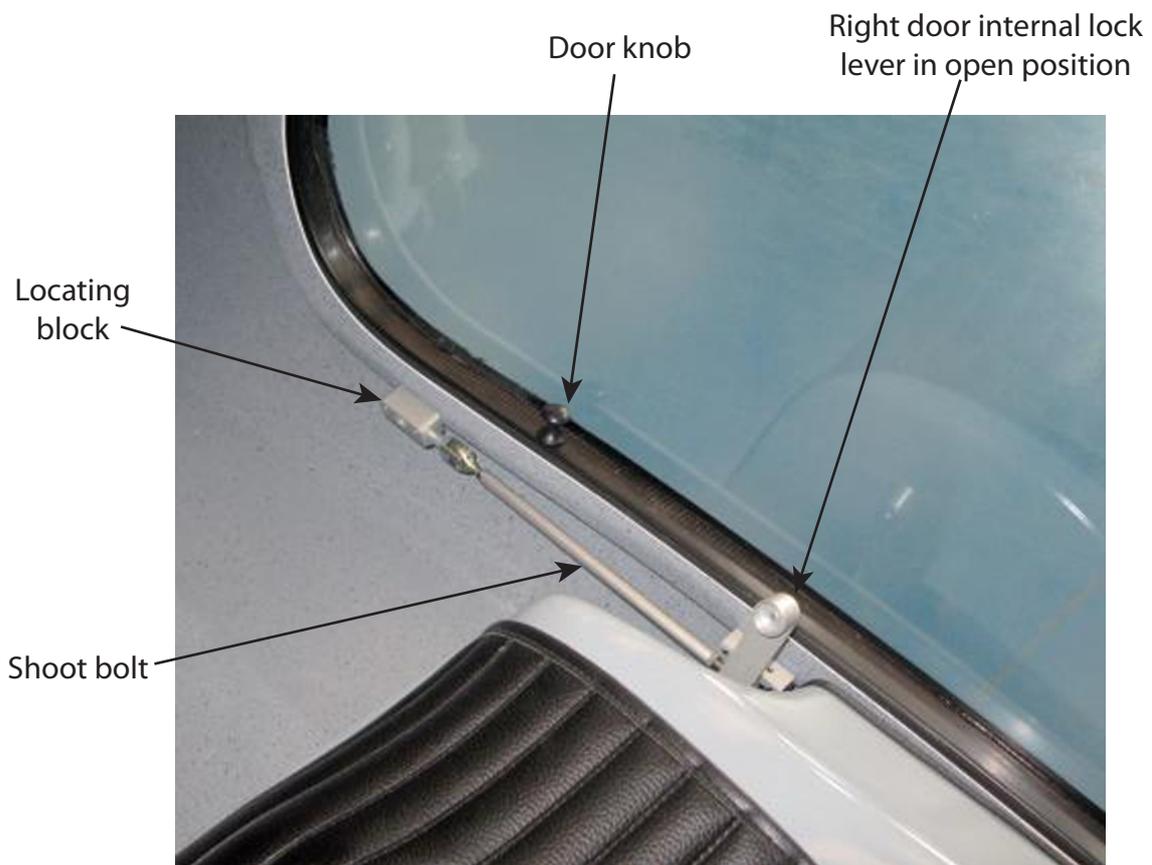
**Figure 4**

Right door operating mechanism

The internal locking lever on the left door is designed such that, when the locking lever is in the unlatched position, contact between the wheel brake operating lever and the internal locking lever limits the forward movement of the throttle lever, see Figure 5. On the aircraft examined by the AAIB, it was noted that with the relative positions of the levers shown in Figure 5, the shoot bolts prevent the spigots from fully engaging in the locating blocks. Thus, if an aircraft takes off with the door lock lever in the closed position, but the door spigots are not latched, the pilot would first have to close the throttle, at least partially, in order for the door lock lever to be moved rearwards a sufficient distance to allow the door to be closed and the spigots to engage fully in the locating blocks. The investigation also found that it is possible for the loose end of a lap strap to become trapped between the door sill and the door, preventing the rear spigot from entering its locating block.

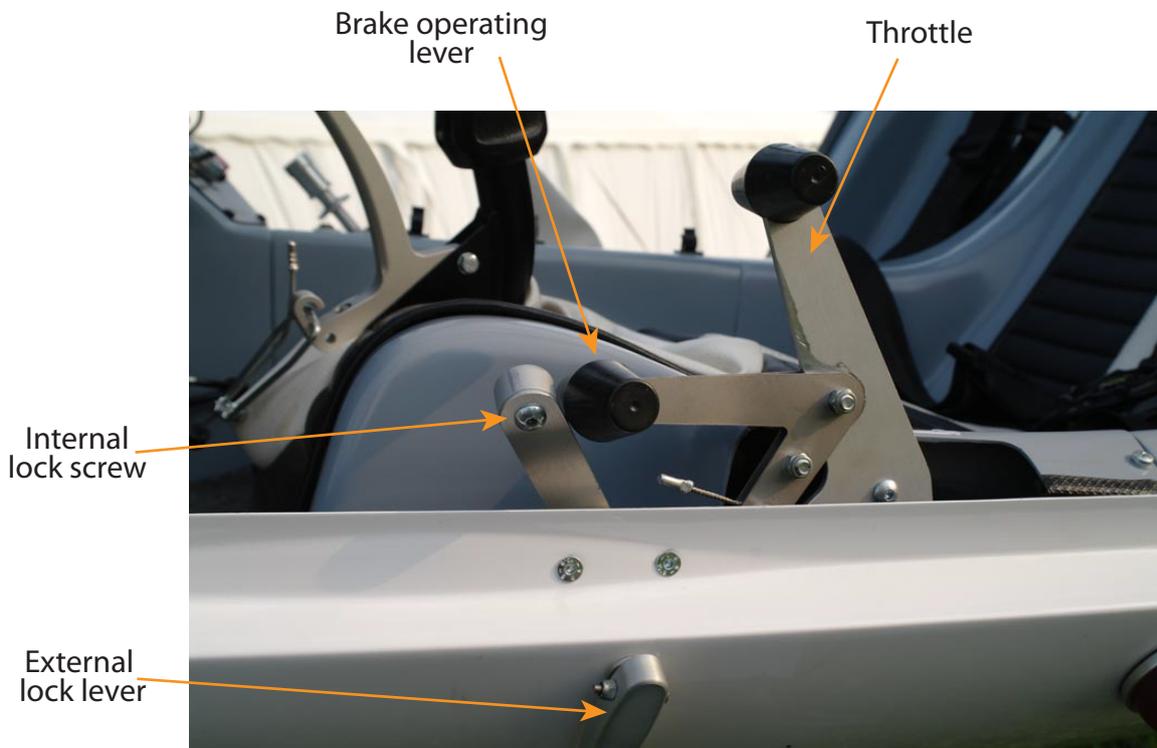
**Figure 5**  
Throttle restricted by internal lock lever.

To latch the door in flight, the pilot would first have to retard the throttle to enable the door lock lever to be moved sufficiently aft in order to withdraw the shoot bolts from the locating blocks. The data from the GPS suggests that the engine power remained at the takeoff setting for most of the flight; therefore the throttle must have remained well forward.
