## SAFETY INFORMATION LEAFLET

# ROTOR BLADE INSPECTION MAGNI M16C & M24C GYROPLANES

**DOCUMENT No:** SIL-002-2011  
**PAGE No:** 1 OF 3

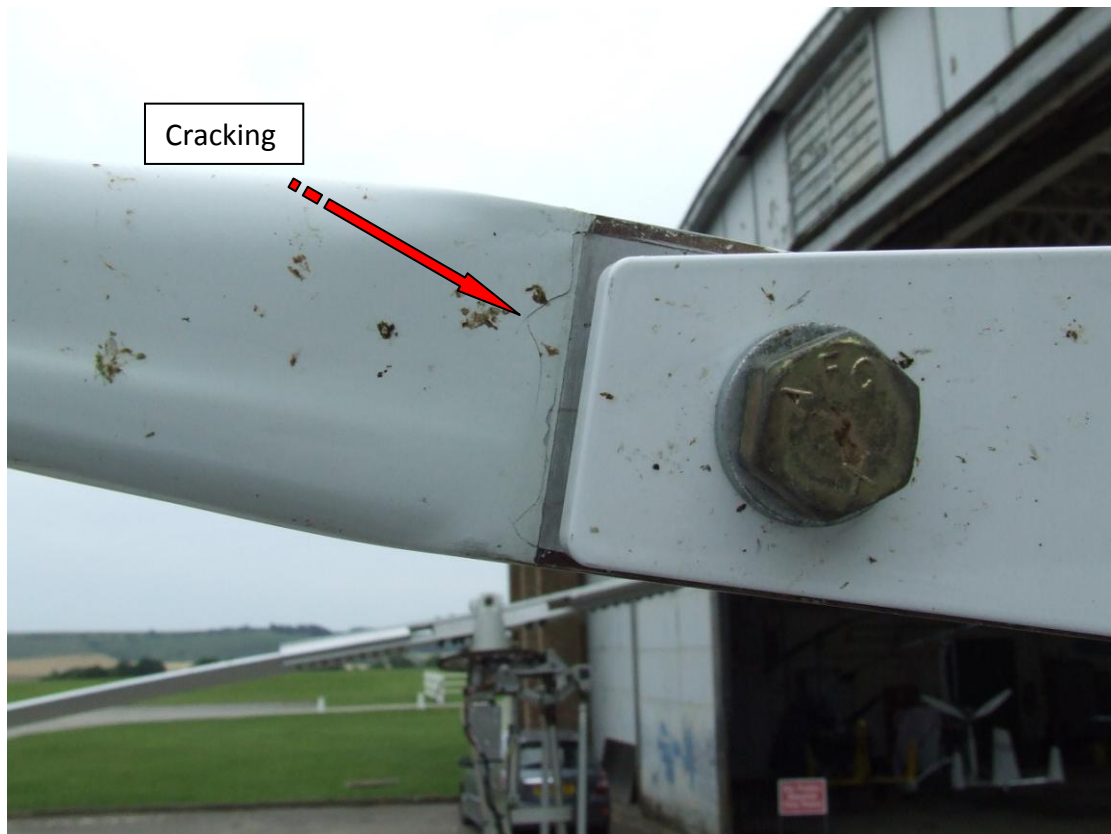
Figure 1 - Cracking Example

The cracks shown in these pictures are due to the flexing of the paint/filler used in the manufacture of the rotor blades. They are not evidence of the onset of structural failure of the main blades.

All operators are currently required to carry out checks on their rotor blades prior to every flight as part of their pre-flight routine. All operators are requested to pay particular attention to their blades during these checks.

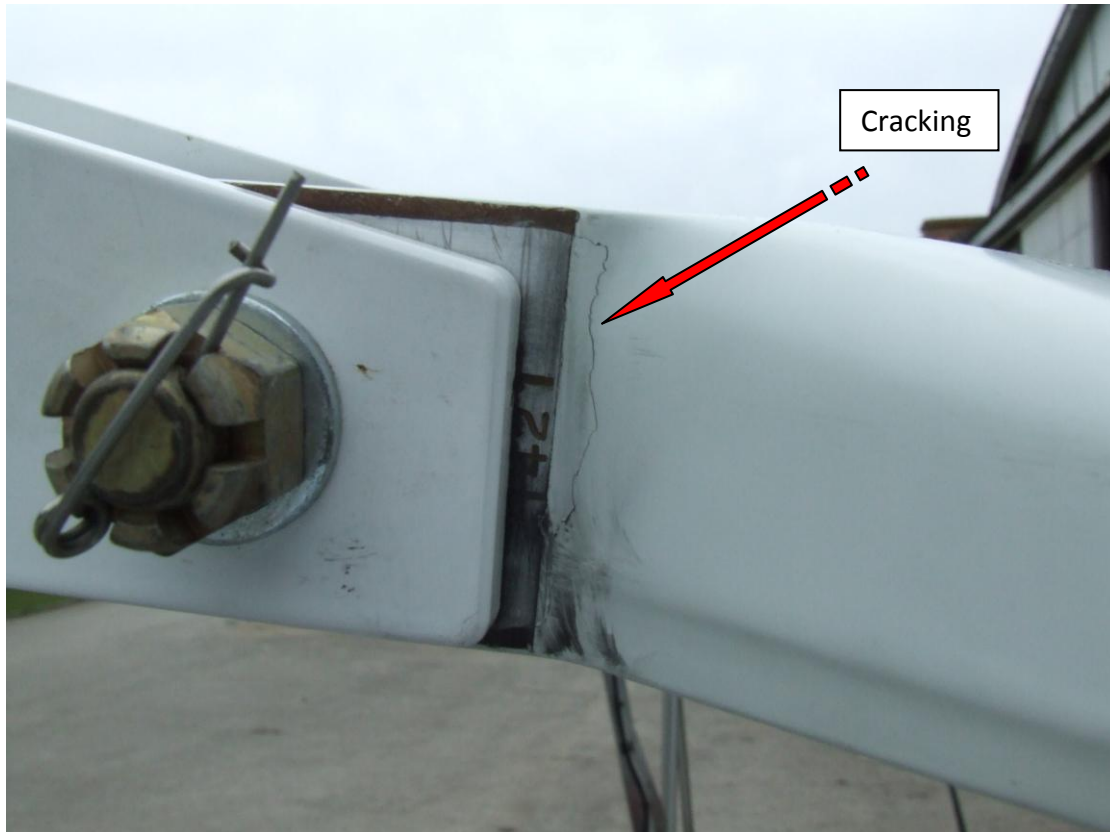
**Figure 2 - Cracking Example**

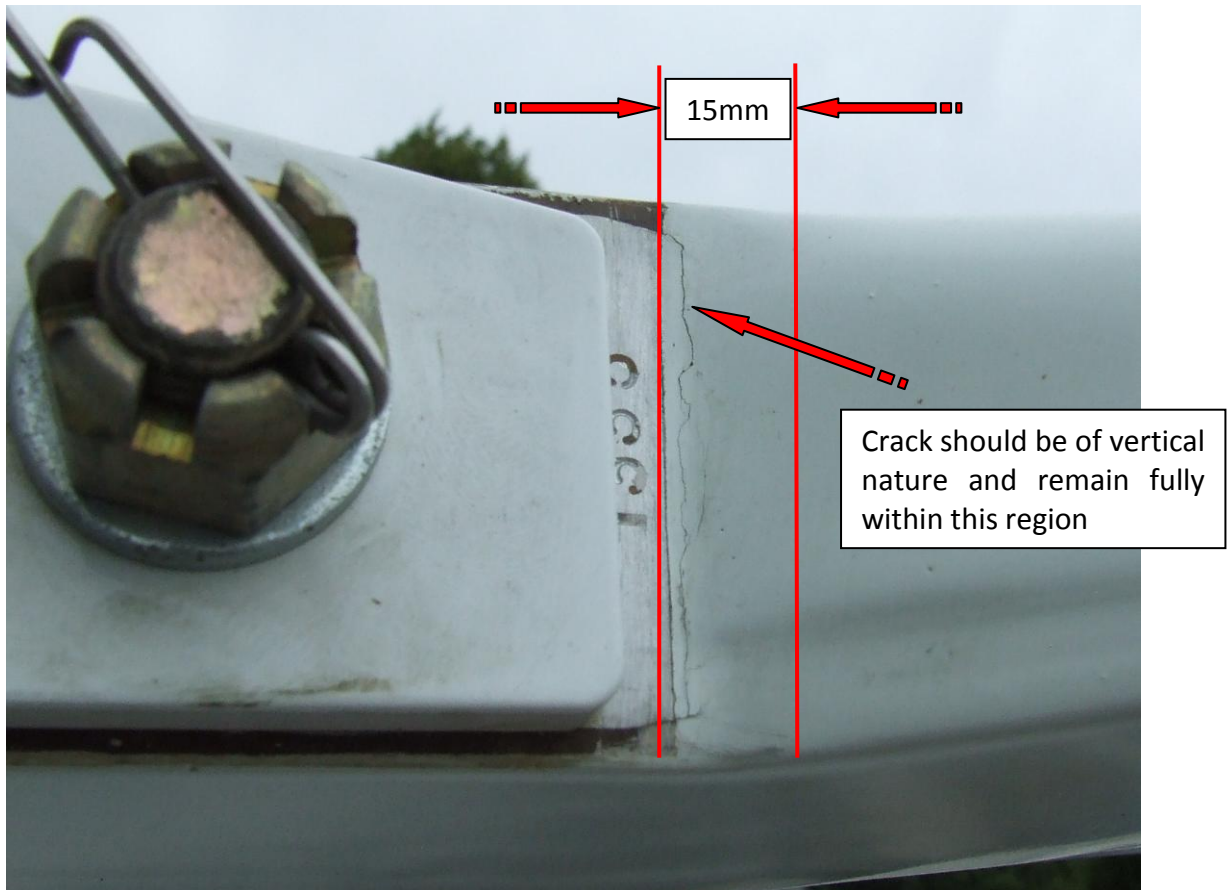
Any cracks should remain within the zone defined in Figure 3 and be of a vertical nature just outboard of the aluminium root fitting. The cracks must only be evident on the fwd or aft faces of the blade – ***they must not extend onto the upper or lower faces of the blade.*** Any cracks that do not conform to the appearance of those shown in the photographs, or lie outside this area should result in the cessation of any further use of the blades.

**Figure 3 - Limit of Paint Cracking Acceptability**

**Immediate consultation of Magni Gyro UK Ltd should be initiated in such instances.**
